Finch Hollow Watershed Project, Site 1. Inventory Number NY-697
Susquehanna River Basin. Broome County,
New York. Phase 1 Inspection Report,

SUSQUEHANNA RIVER BASIN
FINCH HOLLOW WATERSHED PROJECT - SITE I
NY 697
PHASE I INSPECTION REPORT

Name of Dam: Finch Hollow Watershed Project - Site 1
I.D. No. NY 697

Date of Inspection: July 23, 1979

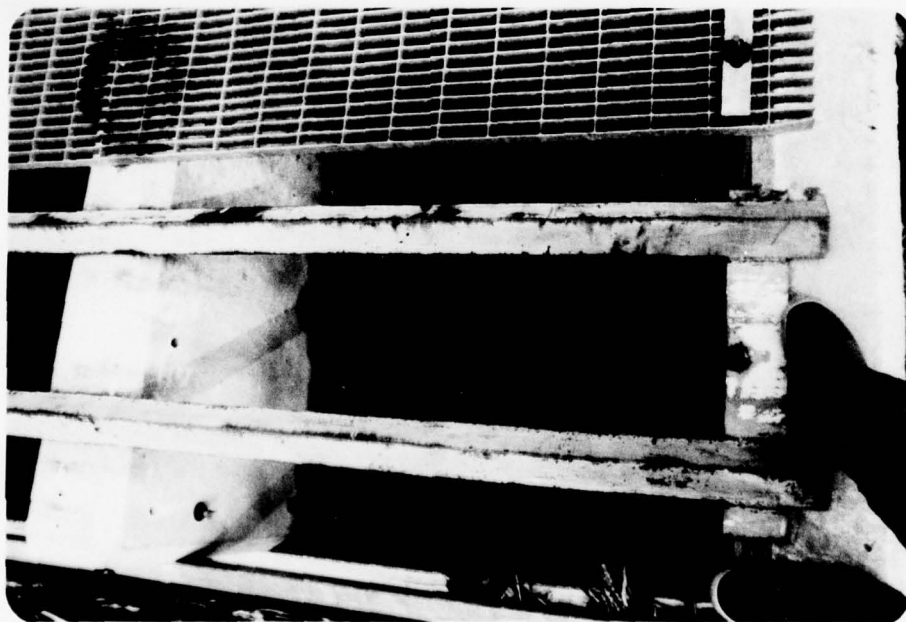
1. The riser top grating is loose and the bolting units require repair. (See photo #5);
2. Considerable debris is surrounding the intake of the principal spillway. This debris should be removed with periodic removals conducted in the future. (See photos #3 & 4).

Grating Atop Riser
Not Missing Bolting Unit Near Boot
Photo #5

b. Principle Spillway structurally good
grate on right side on top of riser is loose
bolting units require repair

n. Intake Structures _____ good condition of concrete
surfaces - bolting units of
grating on right side require
repair

1. Remove the tree growth at the entrance and exit of the auxiliary spillway channel to permit the unimpeded flow of discharge water;
2. Repair the bolting units of the principal spillway riser grating;
3. Remove the debris surrounding the principal spillway riser intake. Provide a program of periodic inspection and maintenance of the dam and appurtenances, including operation and lubrication of the slide gate mechanism. Document this information for future reference;

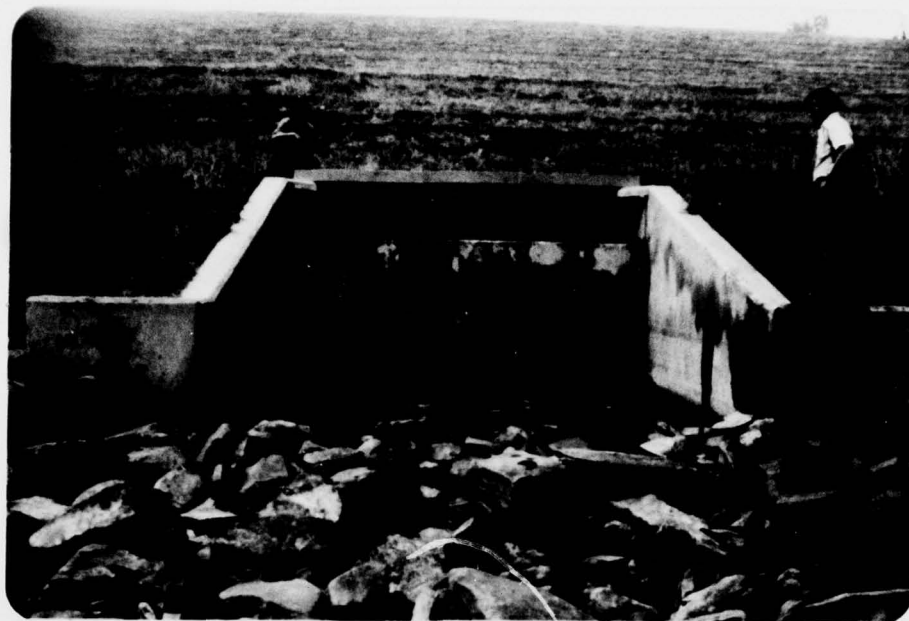
Impact Basin
Photo #6

The principal spillway consists of a vertical drop inlet structure, a reinforced concrete pipe through the embankment; an impact basin at the toe of the embankment, and an outlet channel. (See photos #3, 4, 6, 7, & 11). These components appear to be in satisfactory condition with the following exceptions:

m. Energy Dissipators (plunge pool, etc.) _____
impact basin - good condition

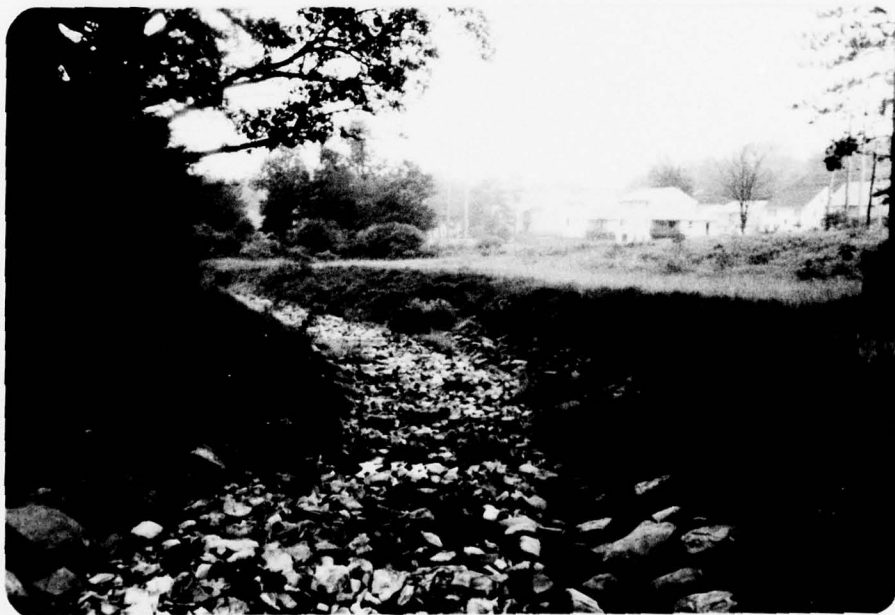
Downstream Channel Below Impact Basin
Photo #11

d. Condition of Tail race channel good condition - ripraped

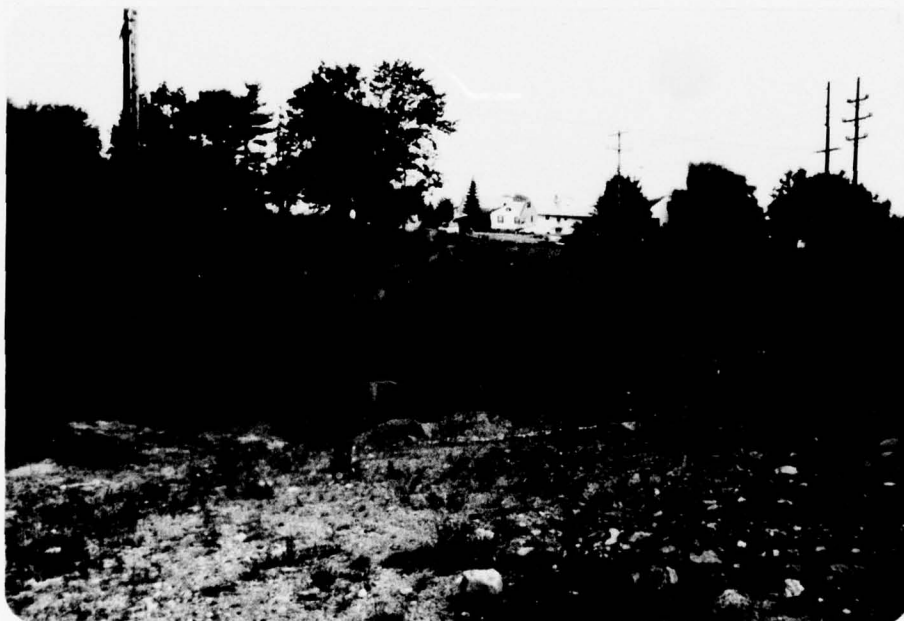
Highway Embankment Below Dam
Photo #13

The Phase 1 inspection of the Finch Hollow Dam Site 1 did not reveal conditions which constitute a hazard to human life or property. The earth embankment is not considered to be unstable. The dam is capable of retarding flood waters resulting from the PMF. However, the location of the highway embankment below the outlet of the auxiliary spillway and the limited hydraulic capacity of the box culvert beneath the embankment may cause an impoundment of flood waters which could flood the homes which are located between the dam and the highway embankment.

- a. Condition (debris, etc.) very little
highway embankment & box culvert
see notes below
- b. Slopes good condition
- c. Approximate number of homes 20 homes near base of dam
on right side of downstream channel, highway embankment
below homes with small box culvert to carry flow from dam
if dam failure occurred flow would back up behind this
- 8) Miscellaneous embankment and flooding of these homes would
occur, particularly if highway embankment culvert
was clogged w/debris

- a. Results of the highway embankment box culvert investigation will determine the type and extent of remedial measures required.
- b. Remove the tree growth at the entrance and exit of the auxiliary spillway channel to provide for unobstructed passage of flow.
- c. Repair the bolting units of the grating at the top of the principal spillway riser.
- d. Remove the debris which surrounds the intake of the principal spillway riser. Provide a program of periodic inspection and maintenance of the dam and appurtenances, including operation and lubrication of the slide gate mechanism. Document this information for future reference.
- e. Develop an emergency action plan for notification of downstream residents and the proper authorities in the event of heavy auxiliary spillway discharge.
